DIAGNOSIS AND ASSESSMENT OF STRUCTURAL FAILURE OF THE R & D BUILDING AT RIIC, KANYE, BOTSWANA

Kanyeto, O.J., Dithinde, M., and Manisa, M.B.

Department of Civil Engineering, University of Botswana, P/Bag 0061, Gaborone

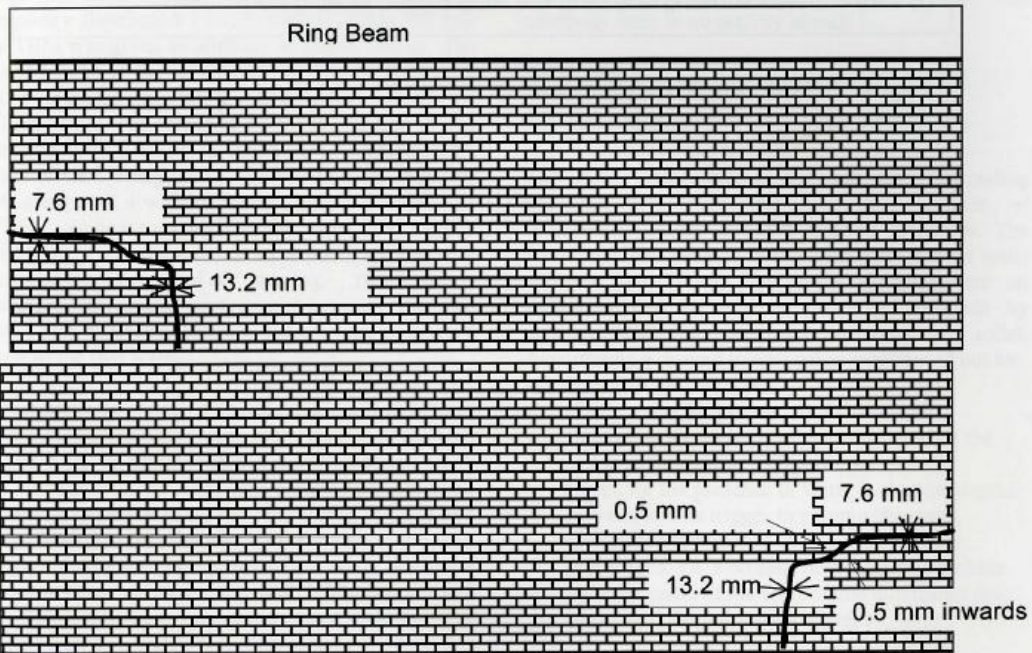
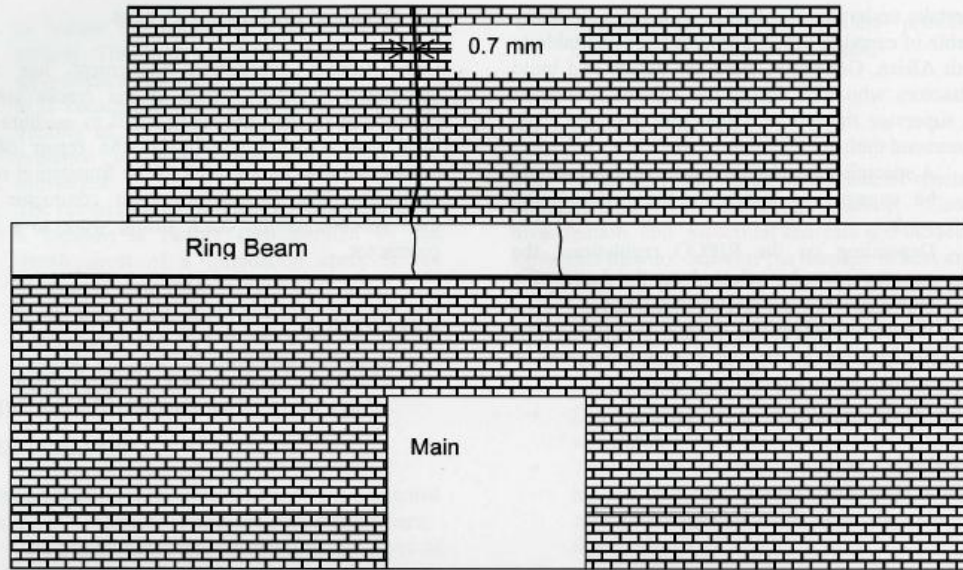
Fig. 2.1: Sketches of major cracks in the Walls and Ring

- The cracks are concentrated at the North-Western side of the building. The largest crack starts at the DPC level in the Western Wall and runs in the vertical direction, Fig 3.1(a) and (b). The crack suddenly changes direction to become horizontal and runs towards the North-Western corner of the building. This type of crack clearly shows the presence of tensile stresses in the region. The crack

extends into the Northern Wall, still running horizontally, Fig. 3.1(c) and (d), and again implying tensile stresses in this region of the wall.

- Other cracks were spotted in the interior walls, most of which run in the vertical direction. Walls spanning in the North-South direction, i.e. the walls parallel to the Western Wall, contain vertical cracks, while walls in the perpendicular direction are cracked horizontally. The vertical cracks in the interior walls are narrow close to the base of the walls and widen as they go up the walls, Fig. 3.1(e).
- Some cracks were spotted in the Ring Beam, in the region around the main entrance to the building. These appear to be shear cracks, Fig. 3.1(f).
- Some minor cracks were also spotted at various other places in the structure.
- The Northern Wall appears to have moved inwards at the DPC level.

(b) Western Wall, looking from inside the building

(f) Eastern Wall showing cracks in the Ring Beam, looking from outside

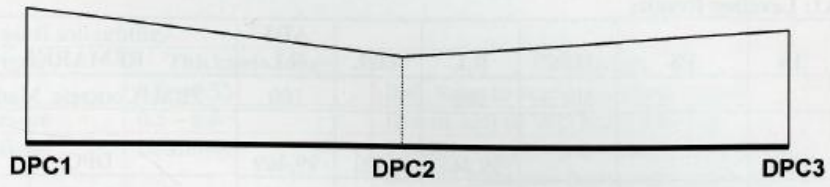
Figure A2: DPC level along wall 1 (not to scale)

Further analysis on wall 1 reveals that the lowest level of DPC along this wall occurs at the middle of the wall (Figure A2). A similar pattern is being noticed along wall 4 (refer to figure A4). This pattern suggests some activity taking place along the central axis of these two walls. Wall 2 shows that the northern side of the wall is higher than the southern side of the wall. A similar pattern is being noticed along wall 3 (Figures A3 and A4). This confirms an observation made earlier on that DPC of wall 4 is higher than that of wall 1. Wall 4 is on the northern side while wall 1 is the southern side.

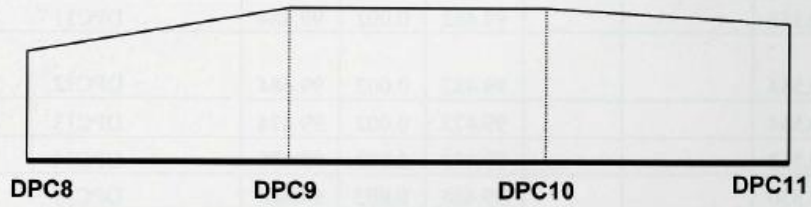
Figure A4: DPC levels along Wall 3 (not to scale)

Wall 3 reveals that the two readings at the middle are higher than those at the ends of the wall. These suggest that the wall might be heaving at those two points. There is a noticeable vertical crack around the same points which suggest a movement of the wall around those two points.

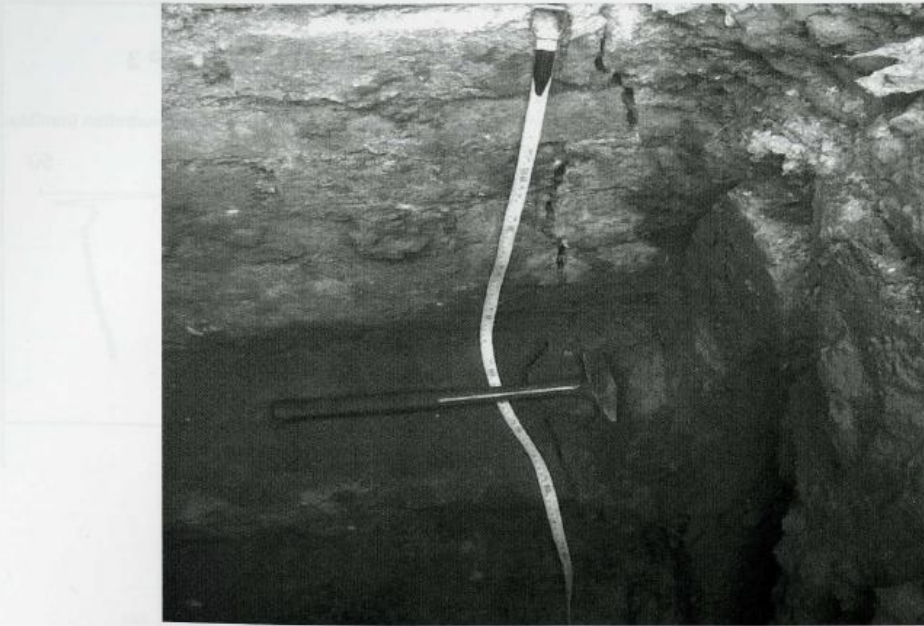
Figure B4: Foundation crack

The theory of the existence of a water spot is further supported by the development of big vertical crack running through the wall to the concrete foundation (Figure B4). This is due to heaving of the wet soil to the north of TP 4 while there was no movement to the south. It is this movement that has set up stress in the wall as well as the ring beam resulting in cracks.

- It is considered that the material within the vicinity of the water sport heaved due to the presence of water leading to differential movement.
- The occurrence of an upward movement at TP 4 location is further demonstrated by the development of a foundation crack at the location.

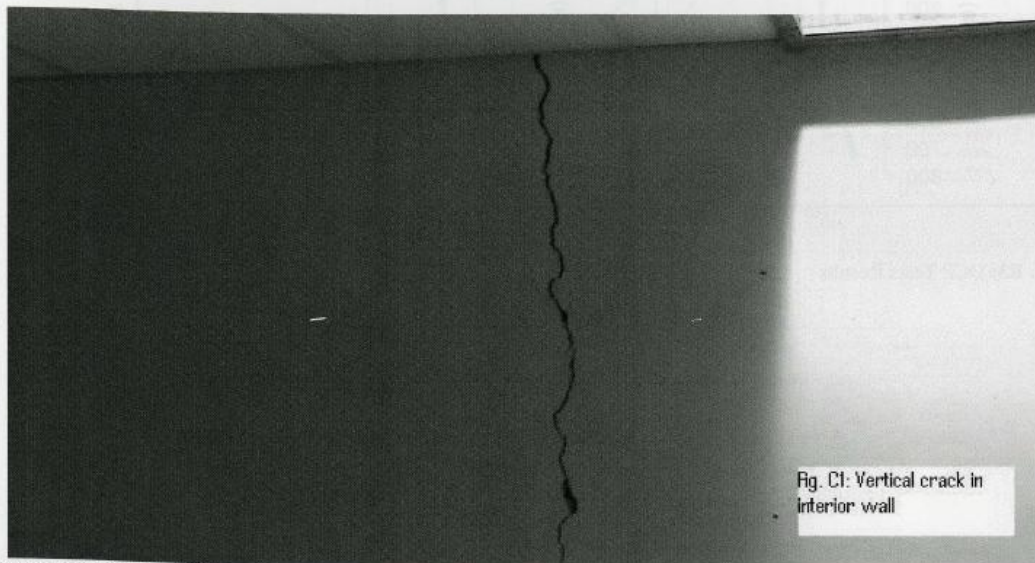
Fig. C1: Vertical crack in interior wall

- The leaning of the Northern Wall is further evidenced by the vertical cracks in the interior walls spanning in the north-south direction. The vertical cracks in these interior walls (particularly the wall dividing the Technology Transfer Unit and the Water & Energy Room) are narrow at the base and widen as they go up the walls.

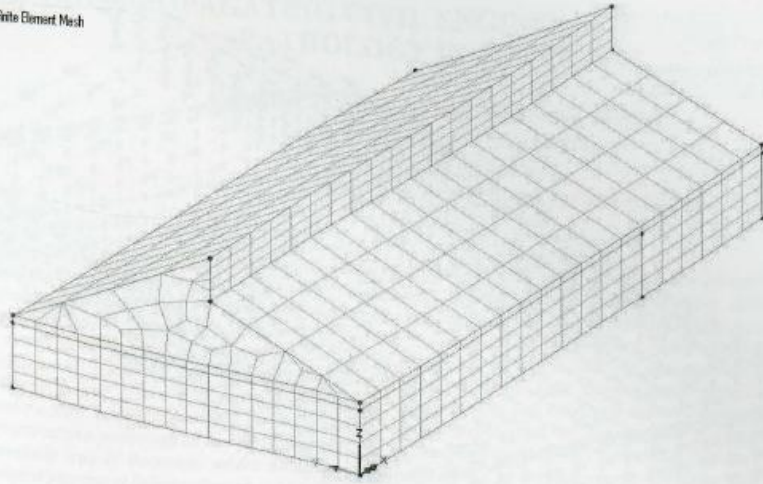
Fig. C3: Original and Deformed Structure
Original Shape ———
Deformed shape ———

Fig.C2 shows the finite element mesh of the building. The results obtained from the FEA are presented in Figs. C3 and C4. Examination of these figures reveals that the differential displacement of the foundation

induces both compressive and tensile stresses in different parts the structure. Furthermore, the relative displacements follow the same pattern as those observed in the real structure.
