DIAGNOSIS AND ASSESSMENT OF STRUCTURAL FAILURE OF THE R & D BUILDING AT RIIC, KANYE, BOTSWANA

Kanyeto, O.J., Dithinde, M., and Manisa, M.B.

Department of Civil Engineering, University of Botswana, P/Bag 0061, Gaborone

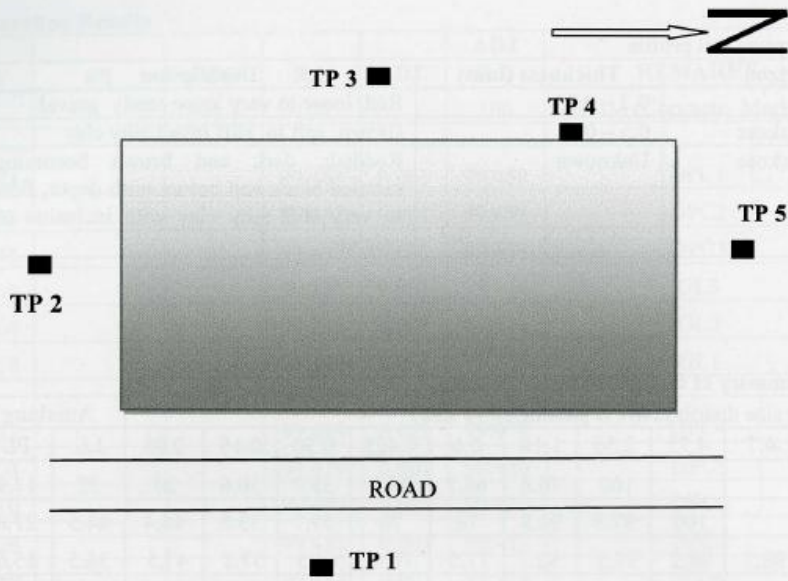
Figure B1: Trial pits locations

- No water table was encountered at the shallow excavation depths.
- No bedrock or hard stratum within the depth of 2m from ground level.
- The material in TP 4 was very wet despite the fact that the location of this trial pit has always been covered with paving blocks to reduce the ingress of rain water to the subsoil. This high moisture content suggests an existence a water spot nearby.

- It is considered that the material within the vicinity of the water sport heaved due to the presence of water leading to differential movement.
- The occurrence of an upward movement at TP 4 location is further demonstrated by the development of a foundation crack at the location.

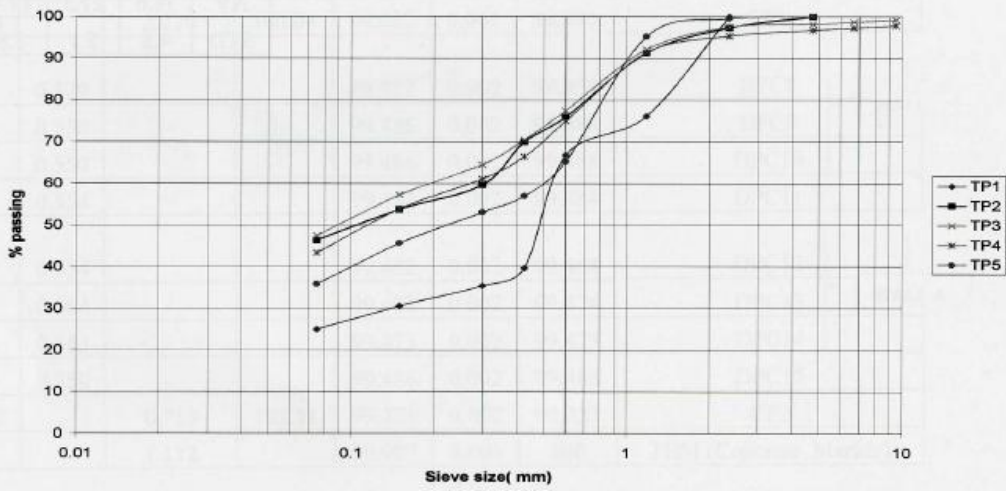
Figure B2: Grading curves

The Atterburg limits obtained are presented in Table B2. The average PI and SL values are 17% and 11 % respectively. This magnitude of PI and SL indicate that there is appreciable clay content in the soil supporting the building. Therefore differential heave resulting in wall cracks is inevitable if foundations are not design for the condition.

From indicator tests results discussed above, it can be concluded that the soil is expansive and not collapsible. Therefore the foundation problem is caused by heave induced by increase in moisture content of the soil.

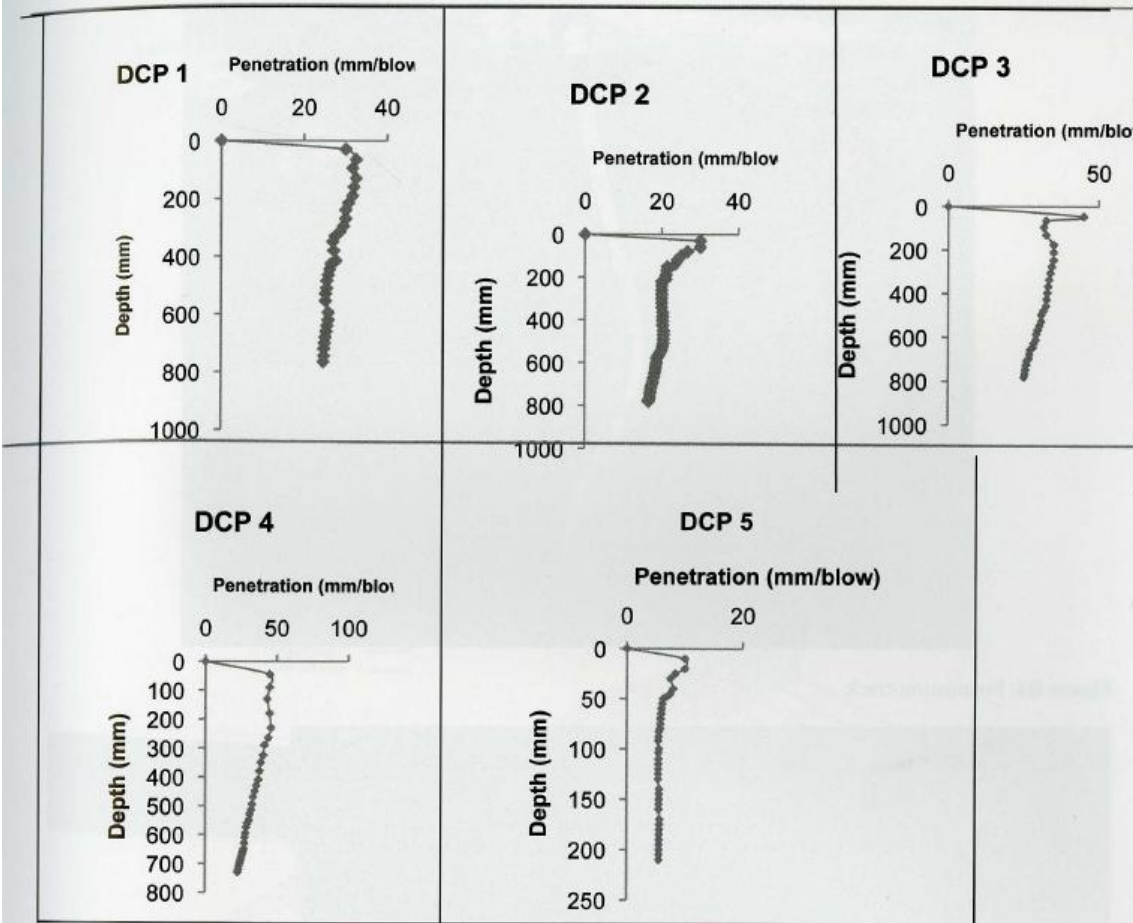
Fig. B3: DCP Tests Results

As already stated, DCP tests were carried out at the bottom of the trial pits to establish the existence of a hard stratum below the foundation. The tests were taken to a depth of about 1m below the foundation level. The results of the DCP tests are presented in Fig. B3. Further analysis of the results shows that the sub-soil is generally of firm to stiff consistency. However the material for TP5 is very stiff in consistency. Although no hard material (i.e. DCP refusal) was encountered in all the trial pits it is evident from DCP soundings curves that the consistency increases with depth. It is estimated that a hard horizon lies at a depth of 2 - 2.5m from ground level.

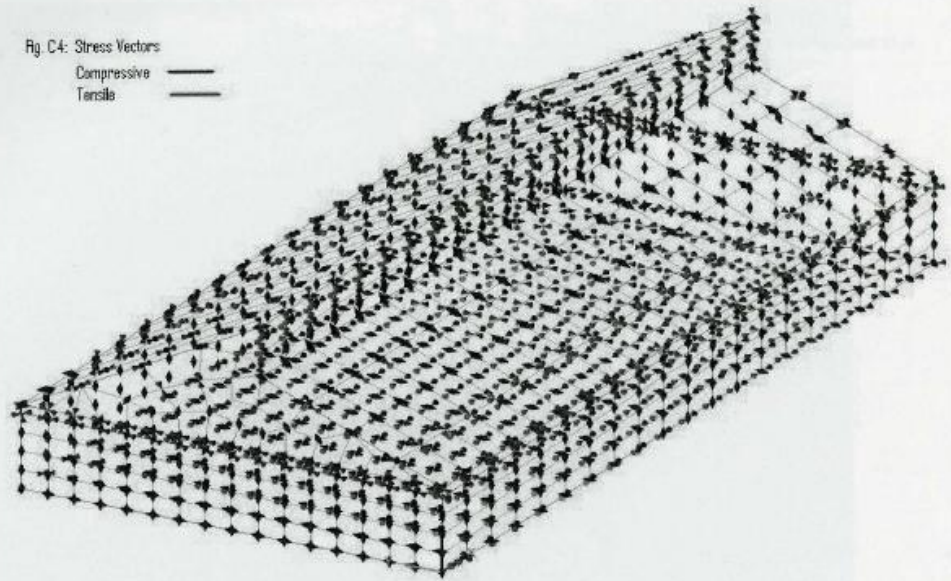
Figure 10: Compressive stress

Fig.C2 shows the finite element mesh of the building. The results obtained from the FEA are presented in Figs. C3 and C4. Examination of these figures reveals that the differential displacement of the foundation

induces both compressive and tensile stresses in different parts the structure. Furthermore, the relative displacements follow the same pattern as those observed in the real structure.

To compute displacement and stress magnitudes using the FEA model would require more exact modeling of the structure, with all parameters properly accounted for. However, judging by the distribution pattern of the stresses and the crack sizes, it can be reasonably concluded that considerable tensile stresses had been induced in the cracked regions of the walls as a result of the foundation displacement. Hence, it cannot be ruled out that other areas which have not developed cracks are still subjected to some tensile stresses. Due to the brittleness of the material, tensile stresses must be avoided by all means in brick buildings, especially where the walls are all load-bearing. Excessive tensile stresses in other regions of the walls may lead to sudden failure (collapse) of some parts of, or the entire, building.
